Docket No. 217 – Development and Management Plan Inspection

Northeast Utilities Service Company Certificate of Environmental Compatibility and Public Need for the construction of a 345-kV electric transmission line and reconstruction of an existing 115-kV electric transmission line between Connecticut Light and Power Company's Plumtree Substation in Bethel, through the towns of Redding, Weston, and Wilton, and to the Norwalk Substation in Norwalk, Connecticut.

Date: August 16, 2006

Location: Transition Stations: Hoyts Hill, Archers Lane, Norwalk Junction

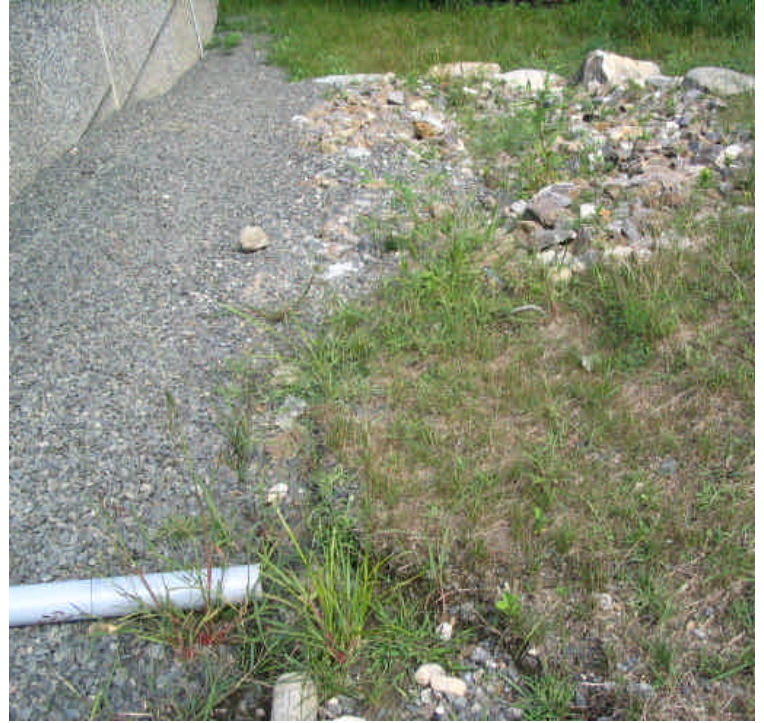
Areas of Inspection	Observation	Recommended Action	Corrected Actions
Erosion and Sediment Controls continued	southern slope remains along the stone pad. The surrounding area is revegetating and may be stabilized. 8/16/06.	stabilized adequately or if the gully still needs restoration. 8/16/06.	when feasible

Hoyts Hill Transition Station: Photo on the left shows the newly paved drive up to the station. Photo on the right shows the minor washout gully remaining through the stone pad on the southern slope. 8/16/06

Areas of Inspection	Observation	Recommended Action	Corrected Actions
Vegetative clearing limits or stabilization	<p>-Hoyts Hill: One gully remains through the stone pad on the southern slope. 6/28-8/16/06.</p> <p>- Archers Lane: Consider final stabilization measures for the area so turbid run-off to the wetland will be reduced. 7/26-8/16/06.</p> <p>- Norwalk Junction: -A number of bare soil areas around the perimeter of site should be temporarily stabilized/vegetated due to sediment loading to the swale. 7/26-8/16/06.</p>	<p>- The surrounding area is revegetating. See erosion control section. 6/7-8/16/06.</p> <p>-NU is evaluating potential solutions here. 7/26-8/16/06.</p> <p>- Restore perimeter surfaces wherever feasible (even if it is temporary) 6/1-8/16/06.</p>	<p>-Needs attention when feasible</p> <p>-Needs evaluation</p> <p>-Needs attention</p>
Dewatering Norwalk Junction	-Active dewatering occurs somewhat regularly to the swale. However, some portions need restoration. 8/16/06	-Restore swale when feasible. 8/16/06.	-Needs attention

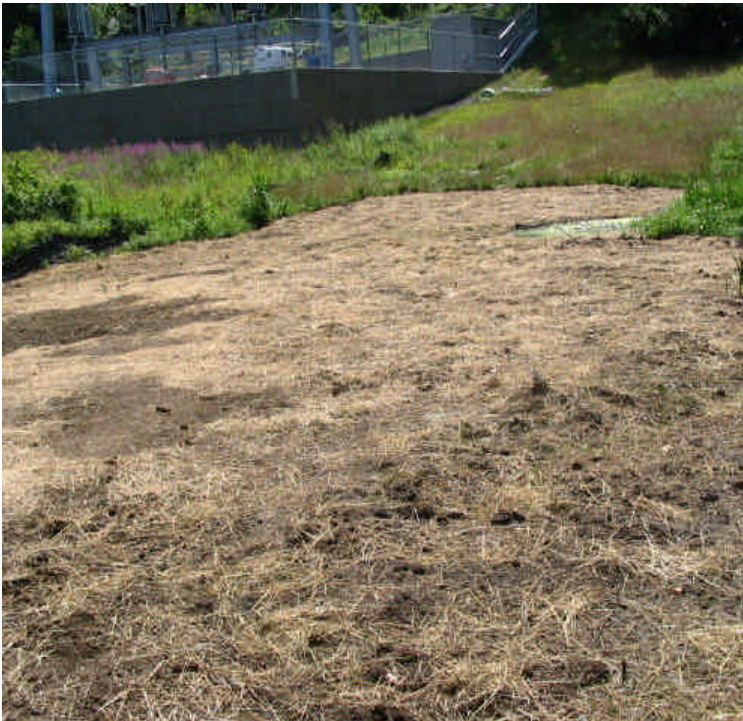
Photo on the left shows the wetland at the base of slope at Hoyts Hill. Timber mats were removed and the area was restored by 345kV XLPE crews. Archers Lane: Photo on the right shows an overview of the station yard. Stone was placed in the yard and some small areas of excavation were present. 8/16/06

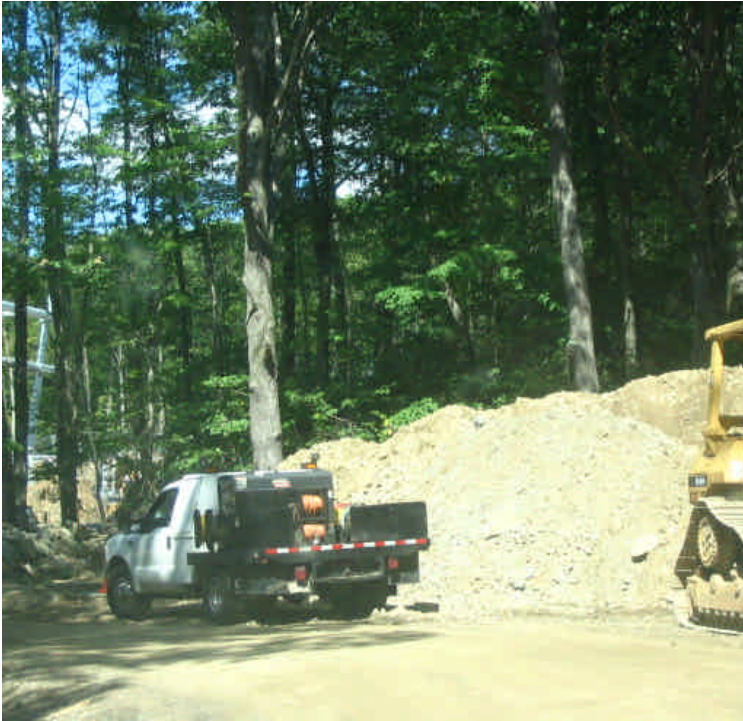
Archers Lane: Photo on the left shows stockpiles remaining along the access road outside of the yard. Slopes along the drive should be restored. Photo on the right shows the repaired silt fence at the top of slope. 8/16/06

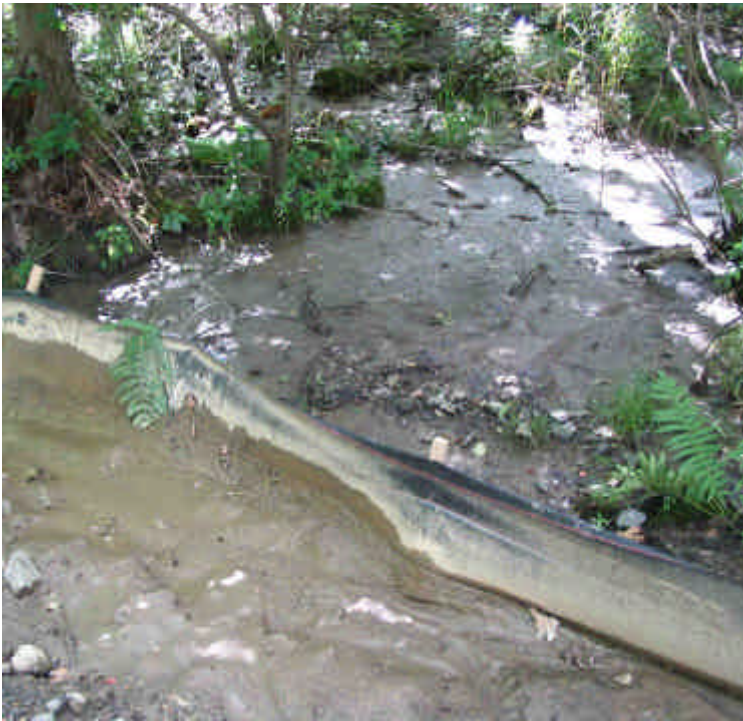
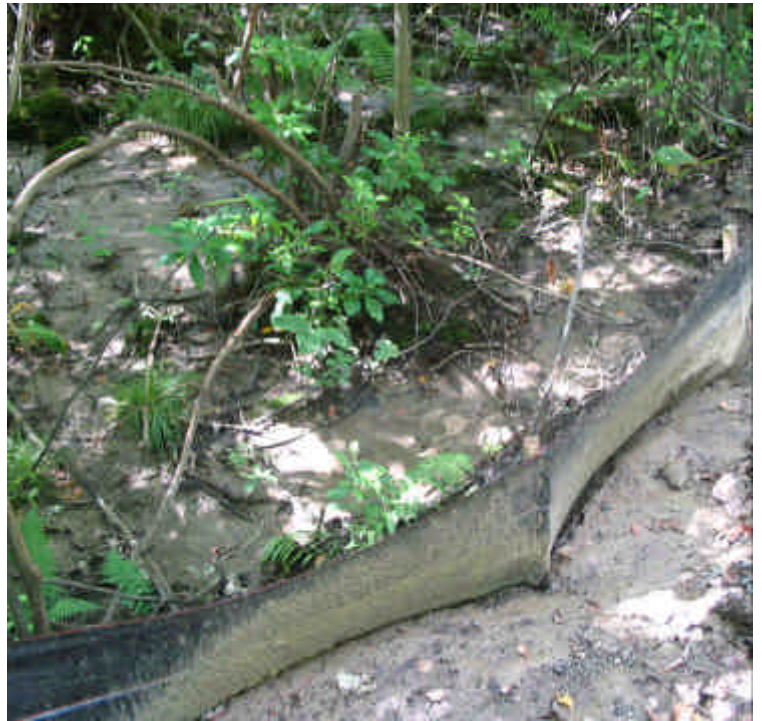
- The silt fence along the access road remains in place but significant accumulated sediment still needs to be removed from the wetland 7/26-8/16/06	- This area will also need some final stabilization measures as this is an ongoing problem. Remove sediment carefully by hand during this dry time of year 8/9-8/16/06	- Needs sediment removal.
	-Slopes remain disturbed along the access road where 345kV trenching occurred and stockpiles remain. 8/16/06	- AL contractors will likely need to perform restoration when work is complete here. 5/4-8/16/06	- Needs attention when work is complete

- Archers Lane: Silt fence along the access road at the 1 st wetland was repaired but significant accumulated sediment remains in the wetland. 7/5-8/16/06	- Remove sediment carefully by hand during this dry period. 7/5-8/16/06 NU is looking into final stabilization measures as this is an on-going problem. 8/16/06	- Still needs attention

Both photos show areas along the silt fence at the first wetland crossing where sediment has accumulated in the wetland with each rain event. NU is looking into a more permanent solution for this but the sediment should be removed by hand in the meantime during this dry period. 8/16/06.

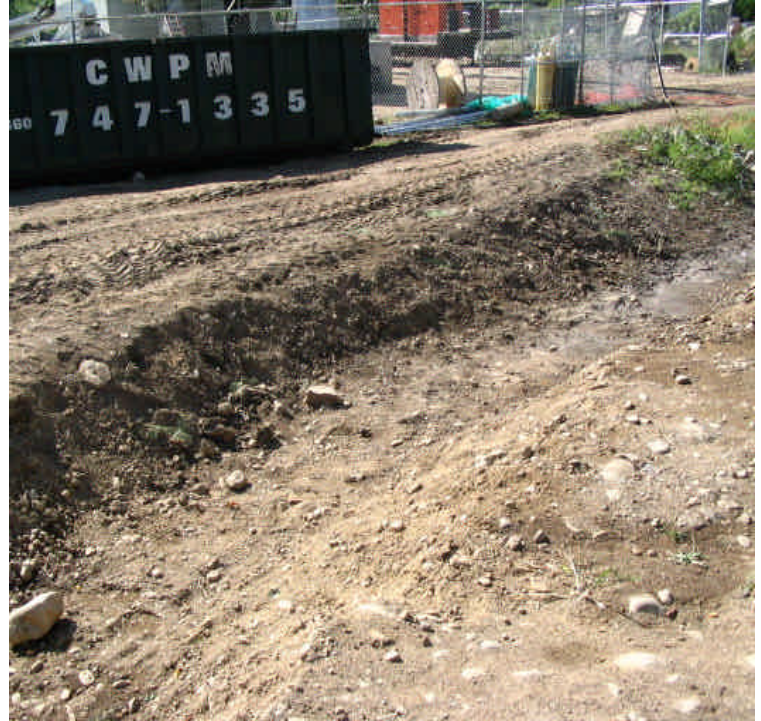
Norwalk Junction: Photo on the left shows an overview of the structure and form work in the yard. Photo on the right shows where the swale was regraded after being filled in for access. Replace stone and revegetate the swale for stabilization 8/16/06.

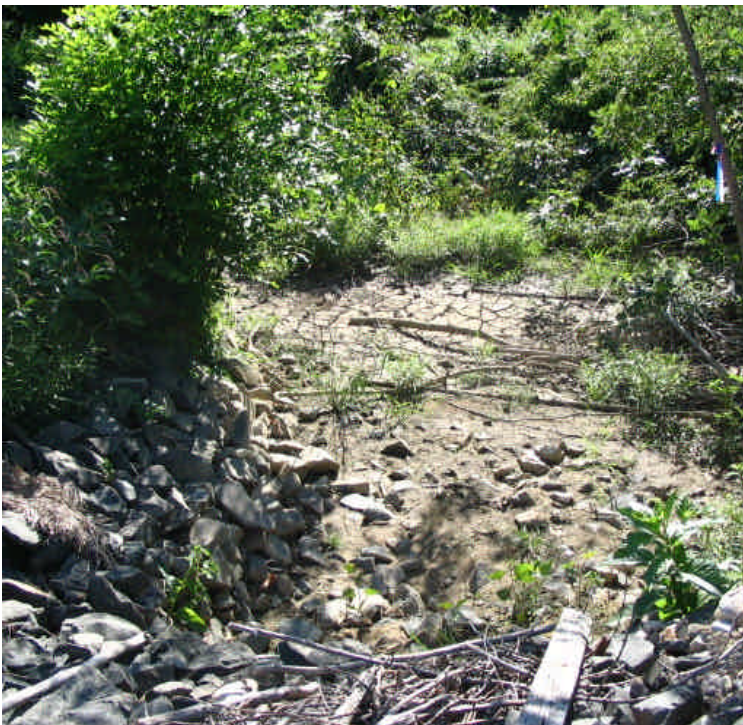
- Norwalk Junction: Perimeter silt fence remain in good shape along the river. 5/17-8/16/06.	- None at this time. Continue to monitor controls. 5/17-8/16/06.	-N/A
	-The wetland area outside the silt fence adjacent to the river contains accumulated sediment. 6/7-8/16/06 -Silt is also building up in the spot closest to the river. 7/26-8/16/06	- The silt is contained and does not yet reach the river. Wetland vegetation was also noted growing here, but silt has built up at the stone outlet and should be removed by hand during this dry period 6/1-8/16/06	- Needs attention

Photo on the left shows the wetland area at the end of swale where sediment has accumulated. It should be removed during this dry period. Photo on the right shows the perimeter of the yard along the silt fence. Restore and revegetate as soon as feasible. 8/16/06.
